FREEZE PROTECTION FOR IMPRESSED- CURRENT, CATHODIC-PROTECTION ANODES IN WATER STORAGE TANKS

MAJ ROGER J. GIRARD
DR JAMES R. MEYERS
ENGINEERING RESEARCH DIVISION

DECEMBER 1979

FINAL REPORT
JANUARY 1976 - DECEMBER 1978

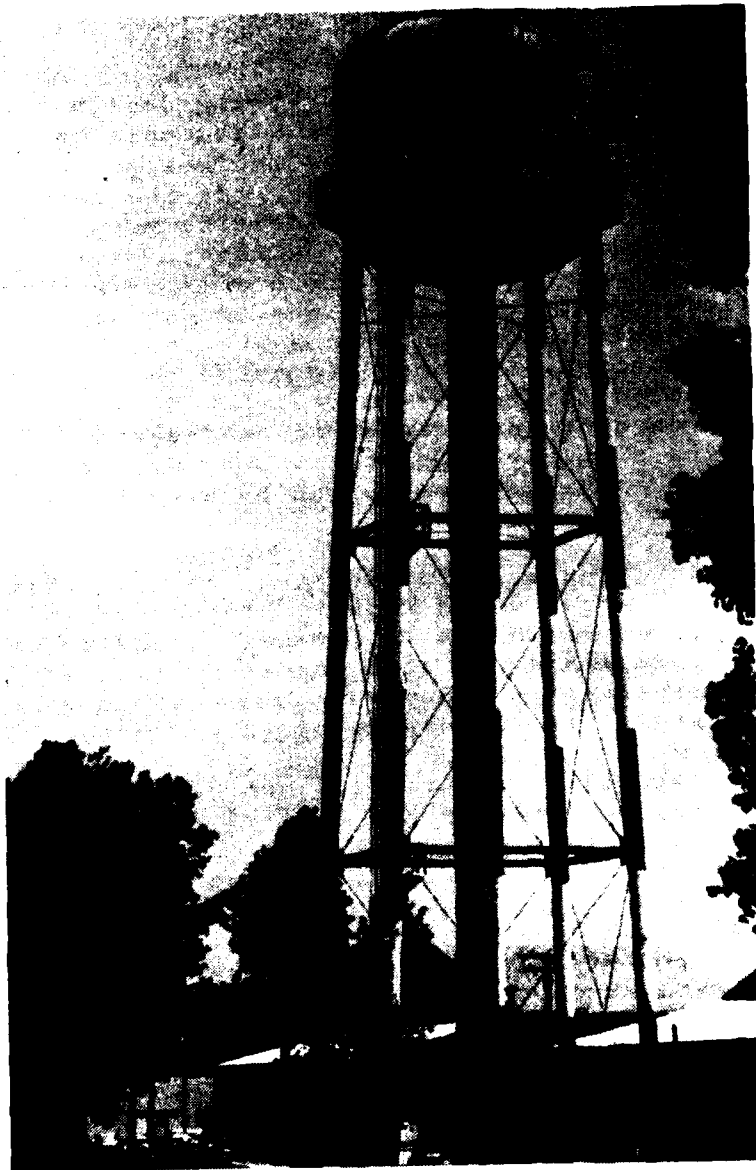
Figure 3. General View of Steel, 100,000-Gallon,
Double-Ellipsoidal Water Storage Tank at
Selfridge Air National Guard Base

The welded-steel, 100,000-gallon, double-ellipsoidal tank (Figure 3) was constructed by Chicago Bridge and Iron Company in 1958. Basically, the structure is approximately 117.5 feet high and has a 5-foot deep pit at its base. The distance between the bottom of the pit and the bottom of the bowl is approximately 96.5 feet; the high and low water levels inside the tank are, respectively, approximately 26 and 15 feet above the bottom of the bowl. Segmented, the heights of the wetted bottom, center, and top sections of the tank are, respectively, 7, 14, and 5 feet. The diameter of the tank at its widest point (i.e., the center section) is 28 feet; the diameter of the riser is 5 feet.

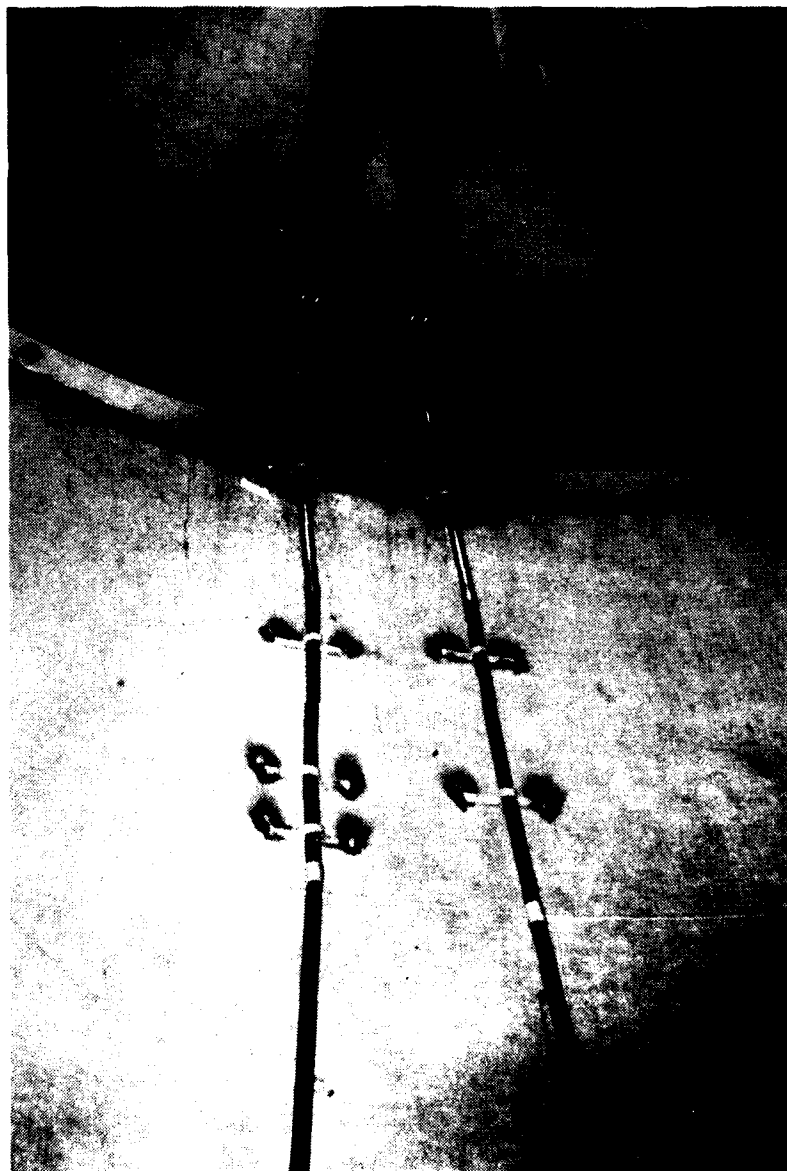
Figure 10. The Anode Header Cables and Reference Electrode Leads Were Exited From the Tank Using Two PVC Conduits Strapped to the Tank Walls

The anode header cables and reference electrode leads were collected and exited from the tank at the top. This was accomplished by placing the cables in two PVC conduits which were strapped in place up the tank wall (Figure 10). Each of the continuous cables and leads terminated at a watertight junction box located on (outside) the roof of the tank. From the junction box to ground level, the header cables and lead wires were protected by placing them inside a 2-inch-diameter flexible PVC conduit which was anchored to a support leg of the tank.
